Visual inspection results and evaluation of Akhtala tailing safety based on tailing management facility safety methodology

K. Sahakyan✉, A. Sarukhanyan

National University of Architecture and Construction of Armenia, Yerevan, Armenia

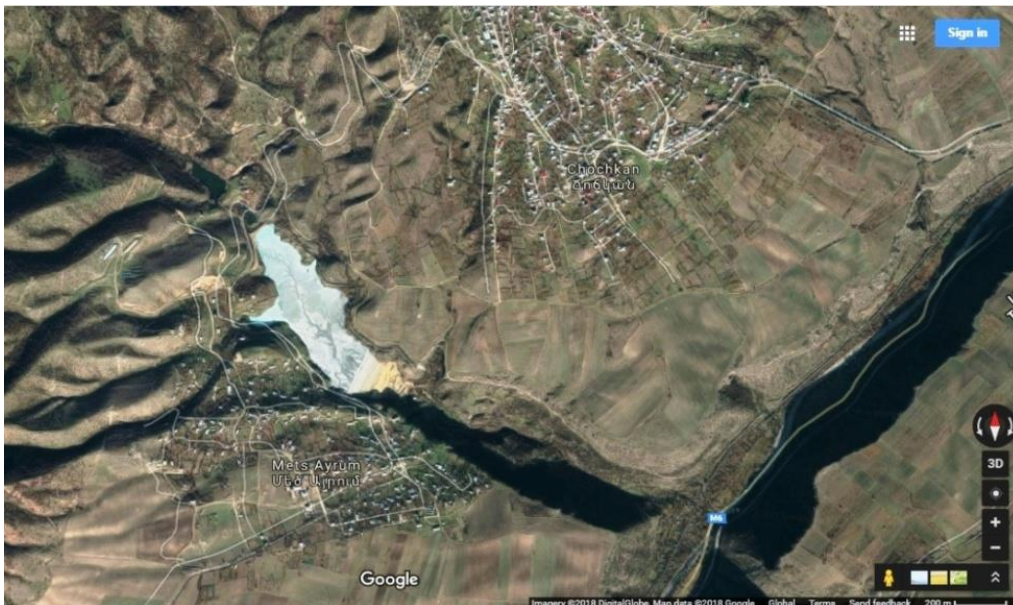
Fig. 1. Location/view of the Nahatak TMF of the Akhtala ore dressing combine

A visual inspection showed that the tailing dump was more than 80% full, and the surface of the lake was approximately 8 ha.

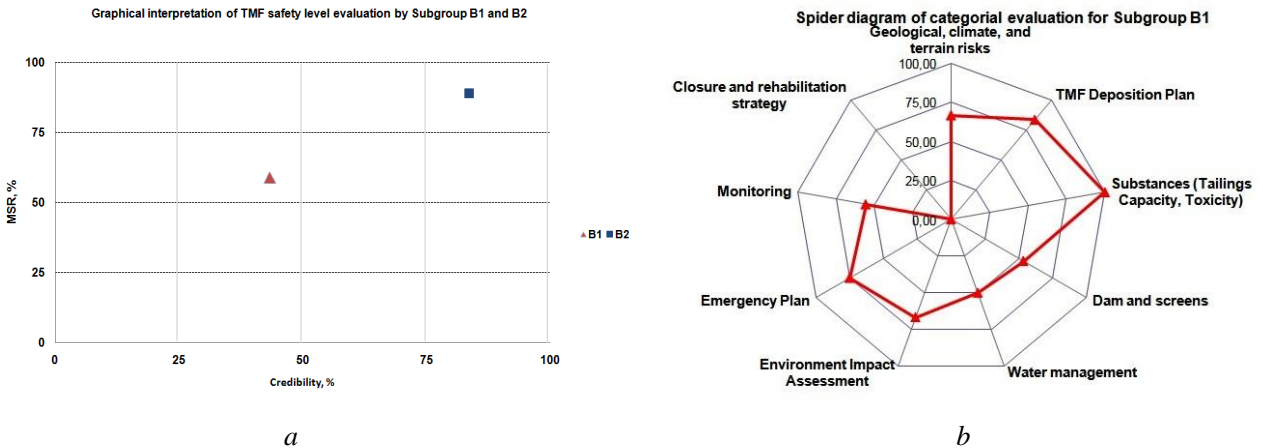
Fig. 2. Safety evaluation results for the main dam: a) overall evaluation; b) categorial evaluation for visual check
Рис. 2. Результаты оценки безопасности главной плотины: а) общая оценка; б) категориальная оценка визуального осмотра

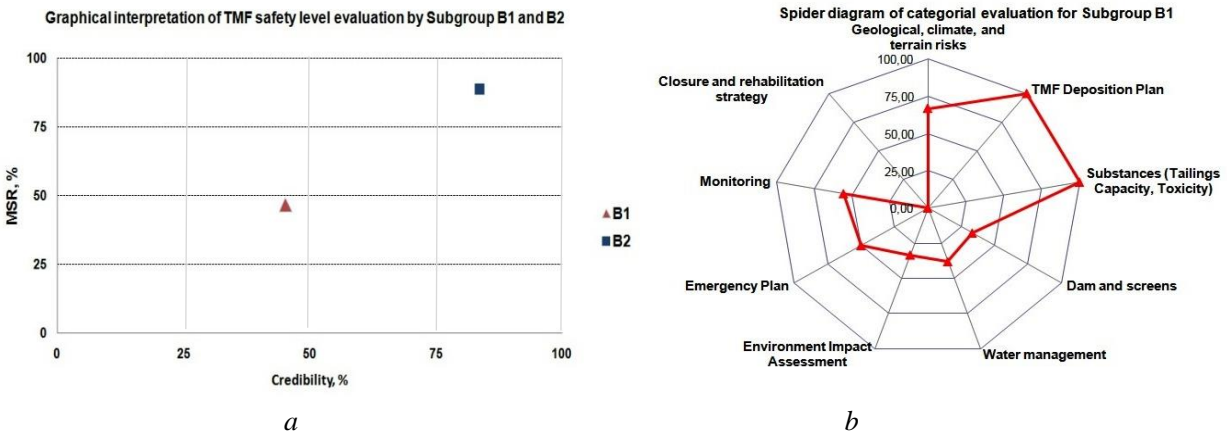
Fig. 1. Safety evaluation results for the drainage canal: a) overall evaluation; b) categorial evaluation for visual check
Рис. 3. Результаты оценки безопасности дренажного канала: а) общая оценка; б) категориальная оценка визуального осмотра

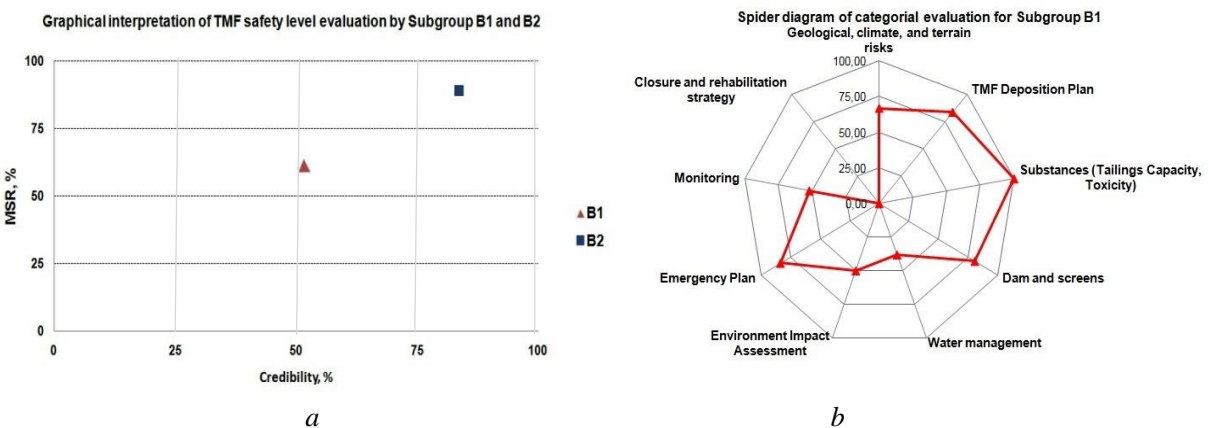
Fig. 2. Safety evaluation results for the secondary dam: a) overall evaluation; b) categorial evaluation for visual check
Рис. 4. Результаты оценки безопасности вторичной плотины: а) общая оценка; б) категориальная оценка визуального осмотра

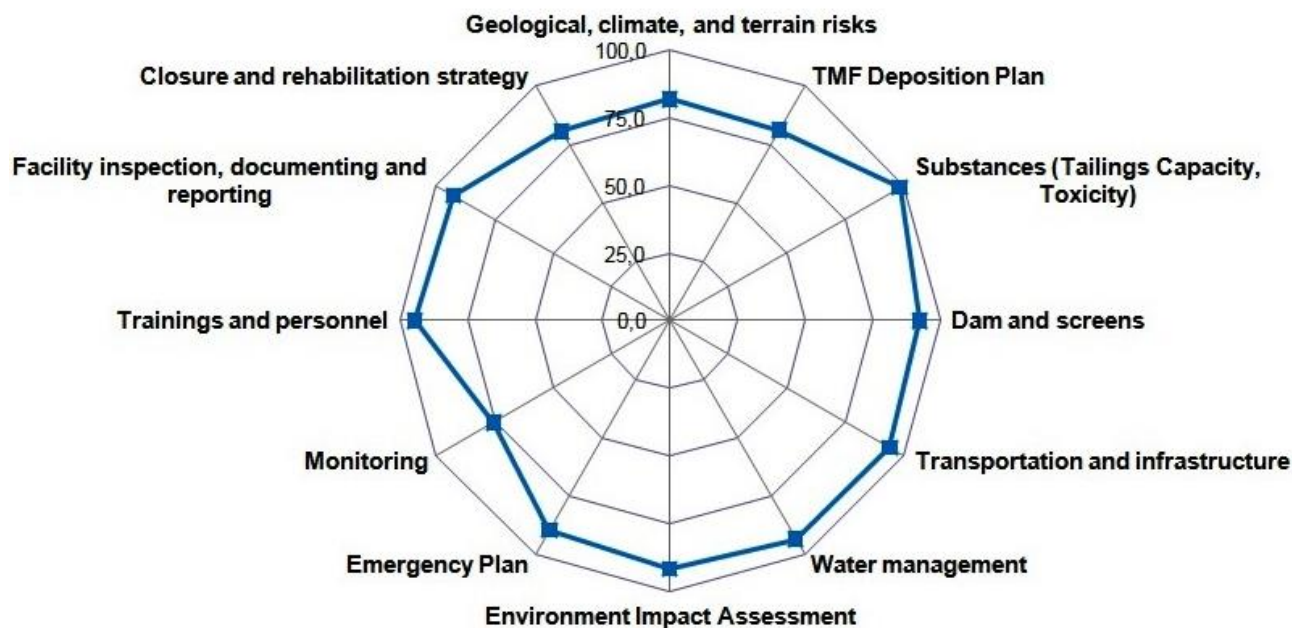
Fig. 5. Safety evaluation results obtained by document check
