Estimation of erosion-deposition trends across the Quang Nam coast in the background of the climate variability

Nguyen Tien Thanh✉

Vietnam National University of Science, Ho Chi Minh City, Vietnam

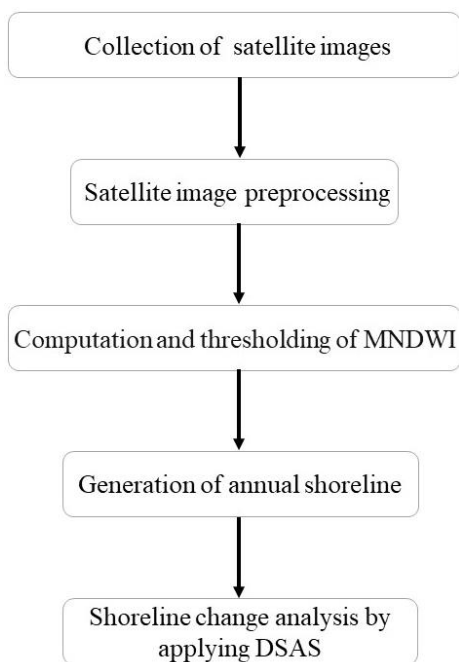
Fig. 3. Flowchart of the research
Рис. 3. Блок-схема исследования

This method has the advantage of detecting water in areas without built-up soil. However, the results, when using NDWI, are often confused between construction ground and water surface. In order to overcome the above-mentioned shortcomings of NDWI, the author in introduced the modification of normalized difference water index, MNDWI by shortwave infrared channel – SWIR (band 6) replaces the NIR channel used in the NDWI formula. In this study, Xu also demonstrated the superiority of MNDWI over NDWI by testing both formulations on three different environments, namely the coastal area of Xiamen City, Bayi Lake and Min River of China and gave results with accuracy up to 99% for all three environments. Xu's modified water difference index has the advantage of extracting water in areas with mainly built-up soil or alluvial soils, but has weaknesses in detecting water bodies with low water content high alluvial concentrations and in the waters surrounding the port [14–18]. Therefore, this study used the MNDWI index for shoreline extraction. The overall methodology is summarized in Fig. 3.

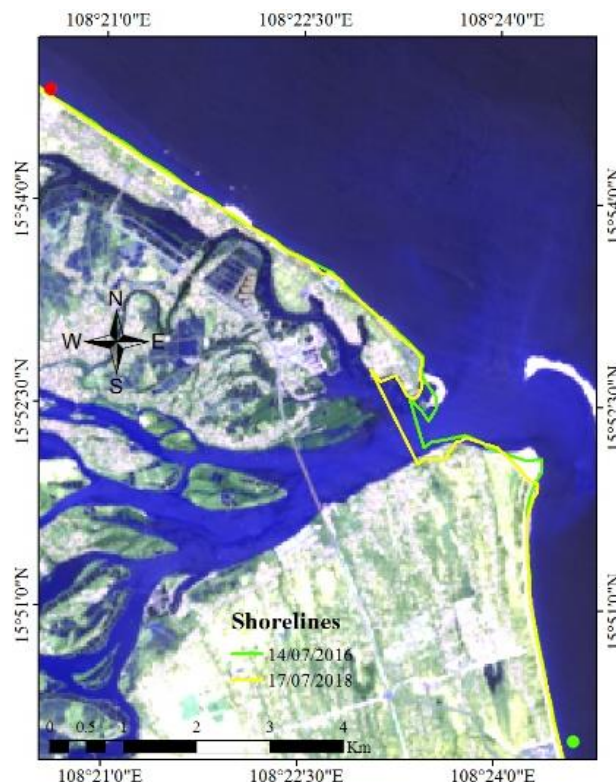
Fig. 4. Change of the area 1 shorelines, 2016–2018
Рис. 4. Изменение береговой линии района 1 в 2016–2018 гг.

The erosion situation in Quang Nam province in recent years has become more and more serious, especially in Cua Dai coastal area (Hoi An City). During the Northeast monsoon season, most of the coast in this section is directly affected by the impact of waves causing erosion–deposition. In the area from An Bang to North Cua Dai in the years from 2016 to 2022, the shoreline has erosion and deposition, but erosion is more dominant. Specifically, in the 2016–2018 period, the erosion rate was 9.2 m/year and the deposition was 5.1 m/year, in the 2018–2020 period, the erosion rate reached 4.5 m/year and the deposition rate was 3.2 m/year, and the period of 2020–2022 erosion was achieved 3.9 m/year and deposition 2.2 m/year. Erosion is concentrated mainly in An Bang beach area, north of Dai estuary, but the extent is decreasing over the years. From the south of Dai estuary to Duy Hai, erosion and deposition occur, but to a greater extent than from An Bang to the North of Cua Dai. Specifically, 2016–2018 – erosion 12.5 m/year and deposition 8.1 m/year, 2018–2020 – erosion 7.1 m/year and deposition 6.5 m/year, 2020–2022 – erosion 7.9 m /year and deposition 36.7 m/year. In general, erosion and deposition occur interlaced and concentrated mainly in the South Cua Dai area (Fig. 4–6, Table 3). The embankment section interspersed with embankments of coastal resorts running along Au Co street, from Cua Dai towards Da Nang for about 2 km was strongly eroded.

| Period Период | An Bang–North Cua Dai | | South Cua Dai–Duy Hải | |
| | Erosion Эрозия | Deposition Отложение | Erosion Эрозия | Deposition Отложение |
| 2016–2018 | 9.2 | 5.1 | 12.5 | 8.1 |

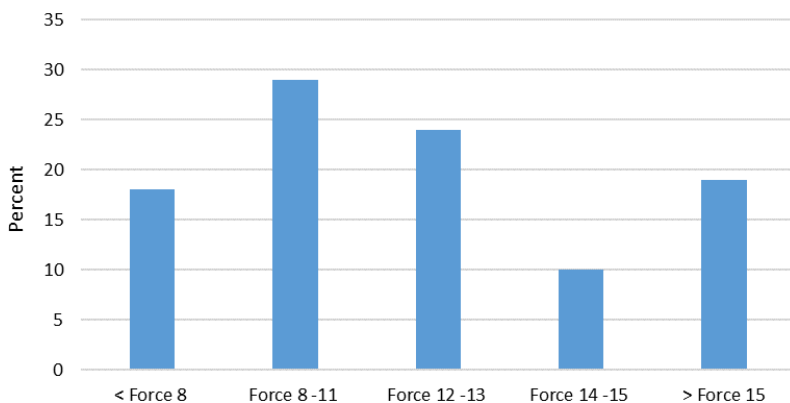
Fig. 13. Beaufort Wind, 1961–2014 [22]
Рис. 13. Ветер Бофорта, 1961–2014 [22]

In addition, in the Quang Nam area, during the northeast monsoon season, it often causes large waves and storms are also active during this period, combined with high tide causing flooding and erosion on a large scale. According to statistics in 1961–2014, there were 206 storms and tropical depressions affecting the central region, of which the most were storms from force 8 to 11 accounting for 29% (Fig. 13). The author in also used the SWAN and SuWAT models to calculate the wave height and storm surge of Typhoon Ketsana with the maximum speed of 130 km/h (force 11), showing that the wave height in Quang Nam area has the maximum level of 6.1 m and the maximum storm surge –
